# Manhole Inspection Summary

Manhole # S61CC\_011MH

Insp Date: **6/9/08 12:15 PM**

**Location** Address: **Pulaski**

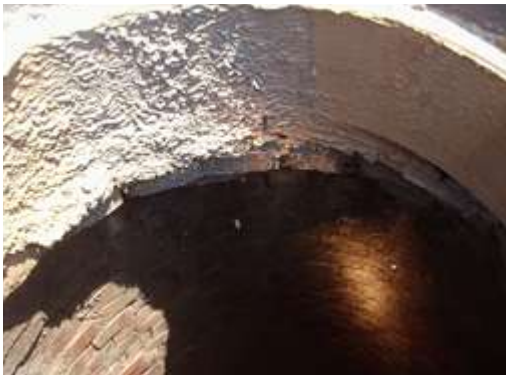
Defect 1

Infiltration: ☐ None ☐ Joint ☐ Cracks ☐ Mortar ☐ Roots ☒ **Wall**

Infiltration

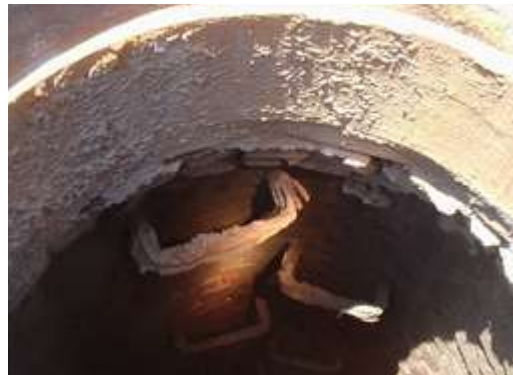
Defect 2

Condition: ☐ Sound ☐ Cracked ☐ Root Intrusion ☒ **Loose Brick** ☐ Deteriorated

Infiltration: ☐ None ☐ Joint ☐ Cracks ☒ **Mortar** ☐ Roots ☐ Wall

Rusty steps, loose bricks

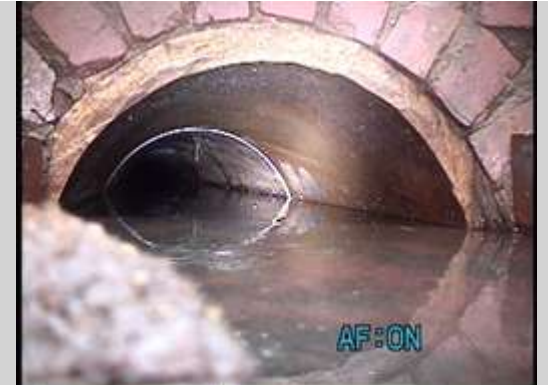
12 O'Clock Outflow

18 in. Circular Gravity Sewer  
Pipe Out @ 12 O'Clock

Pipe Height: **18** (in.) Rod and Bar (Angled)  
Pipe Material: **Clay** ☐ Pipe Lined  
Invert Depth: **9.80** (ft.) Flow Characteristics: **Slow**  
Deposits: ☒ None ☐ Mud ☐ Sludge ☐ Debris ☐ Grease  
Silt Depth: (in.) Deposits Extent:  
Infiltration: **None** Pipe Seal Cond: **Sound**

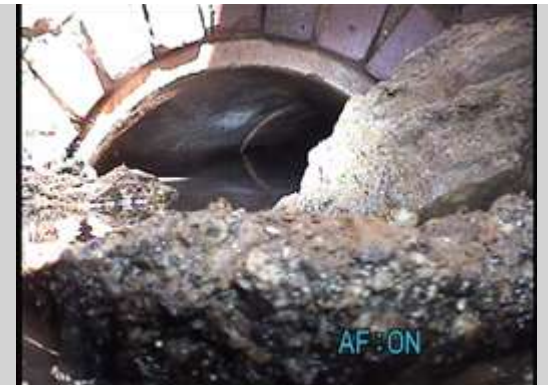
7 O'Clock Inflow

18 in. Circular Gravity Sewer  
Pipe In @ 7 O'Clock

Pipe Height: **18** (in.) Rod and Bar (Angled)  
Pipe Material: **Clay** ☐ Pipe Lined  
Invert Depth: **9.70** (ft.) Flow Characteristics: **Slow**  
Deposits: ☒ None ☐ Mud ☐ Sludge ☐ Debris ☐ Grease  
Silt Depth: (in.) Deposits Extent:  
Infiltration: **None** Pipe Seal Cond: **Sound**
